## *Hydrological restoration of wetlands and streams in headwater areas*

*(LIFE for MIRES, Sumava National Park, Czech Republic)*

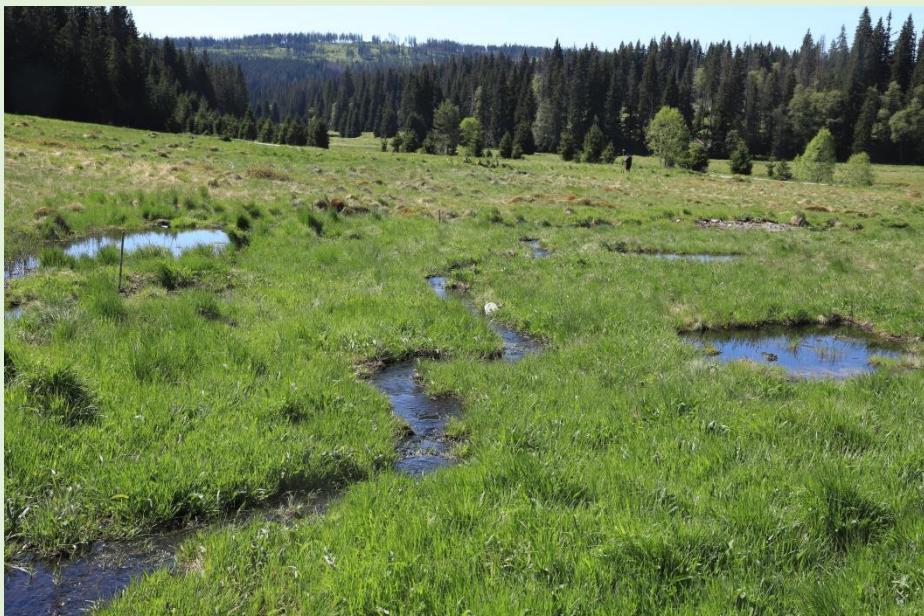
Restored natural stream, blocked channels and created small pools on the Rybarny I site

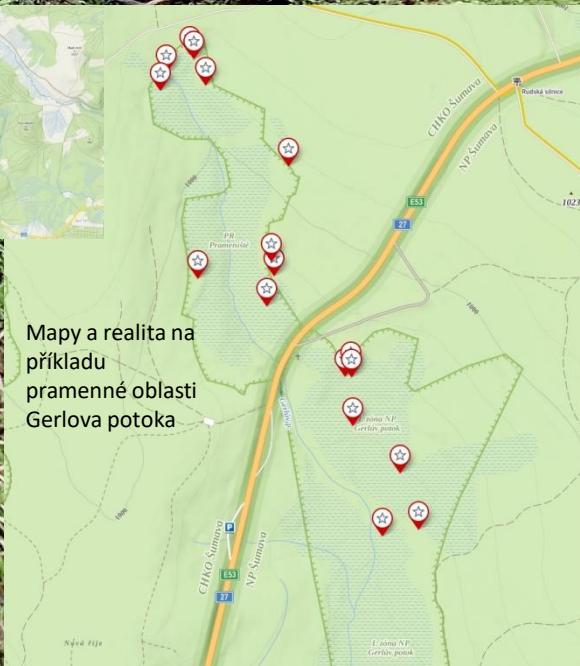
*Large, drained and totally destroyed spring*

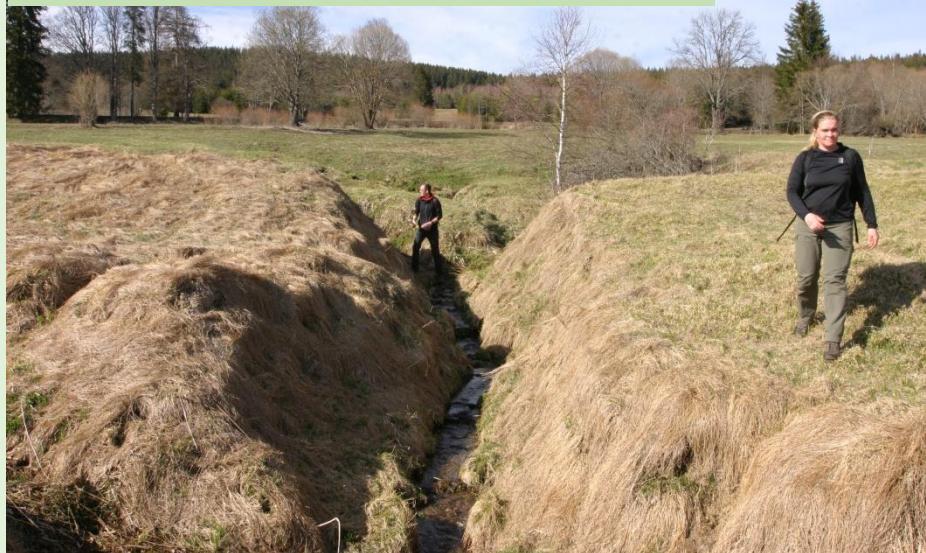
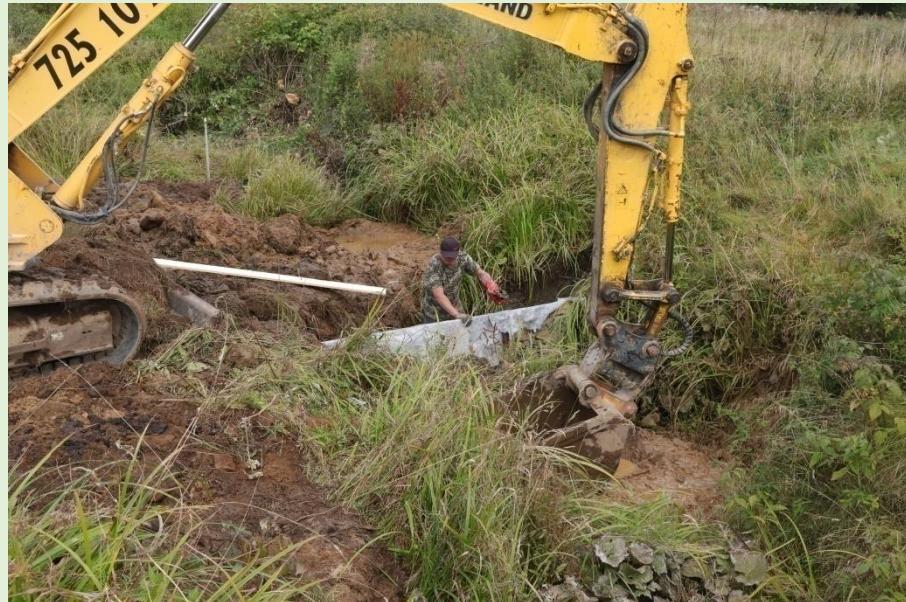
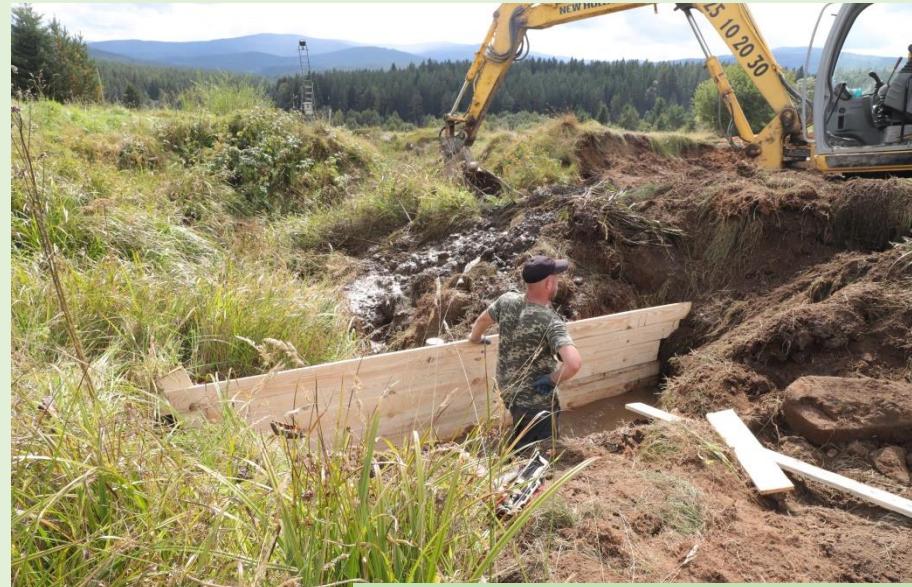
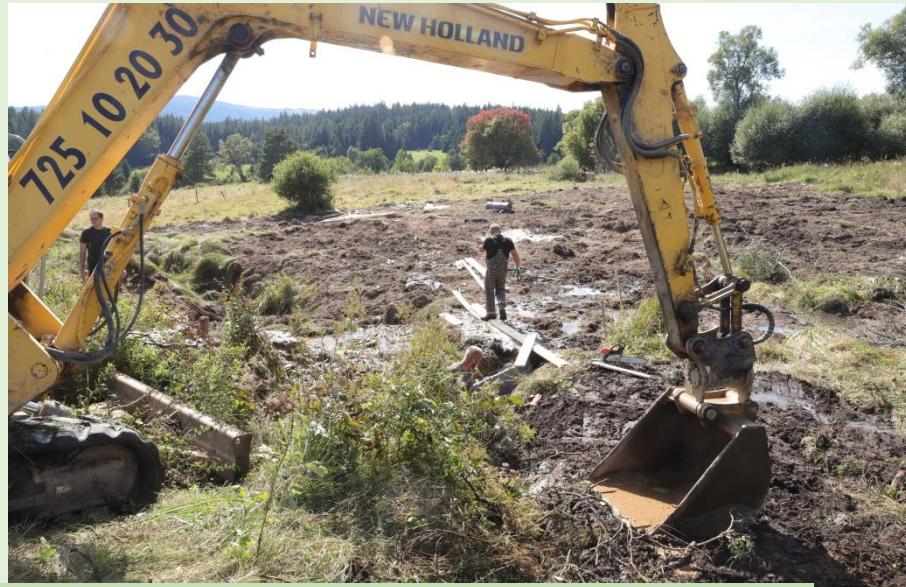
*Blocking of drainage ditches by woody dams, infilling of large pits from bank soil deposits*

One year after restoration (2022)

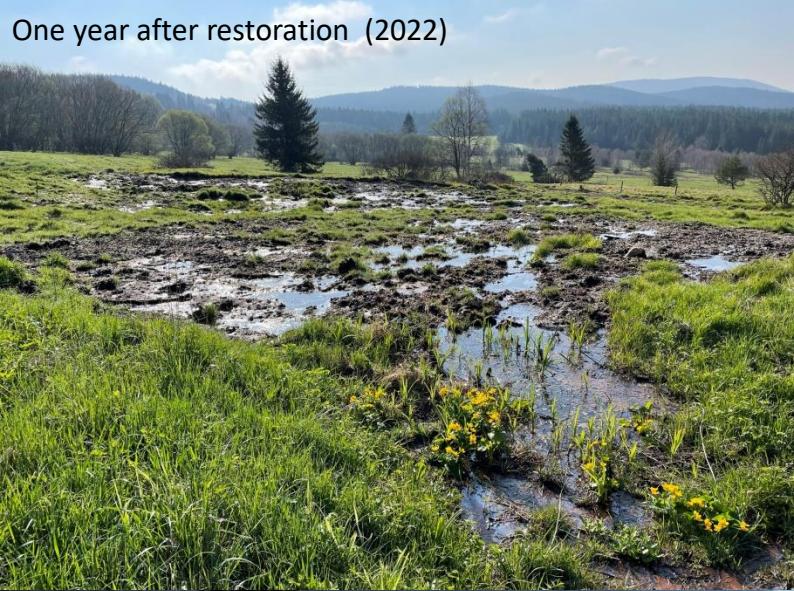
Two months after restoration 2021

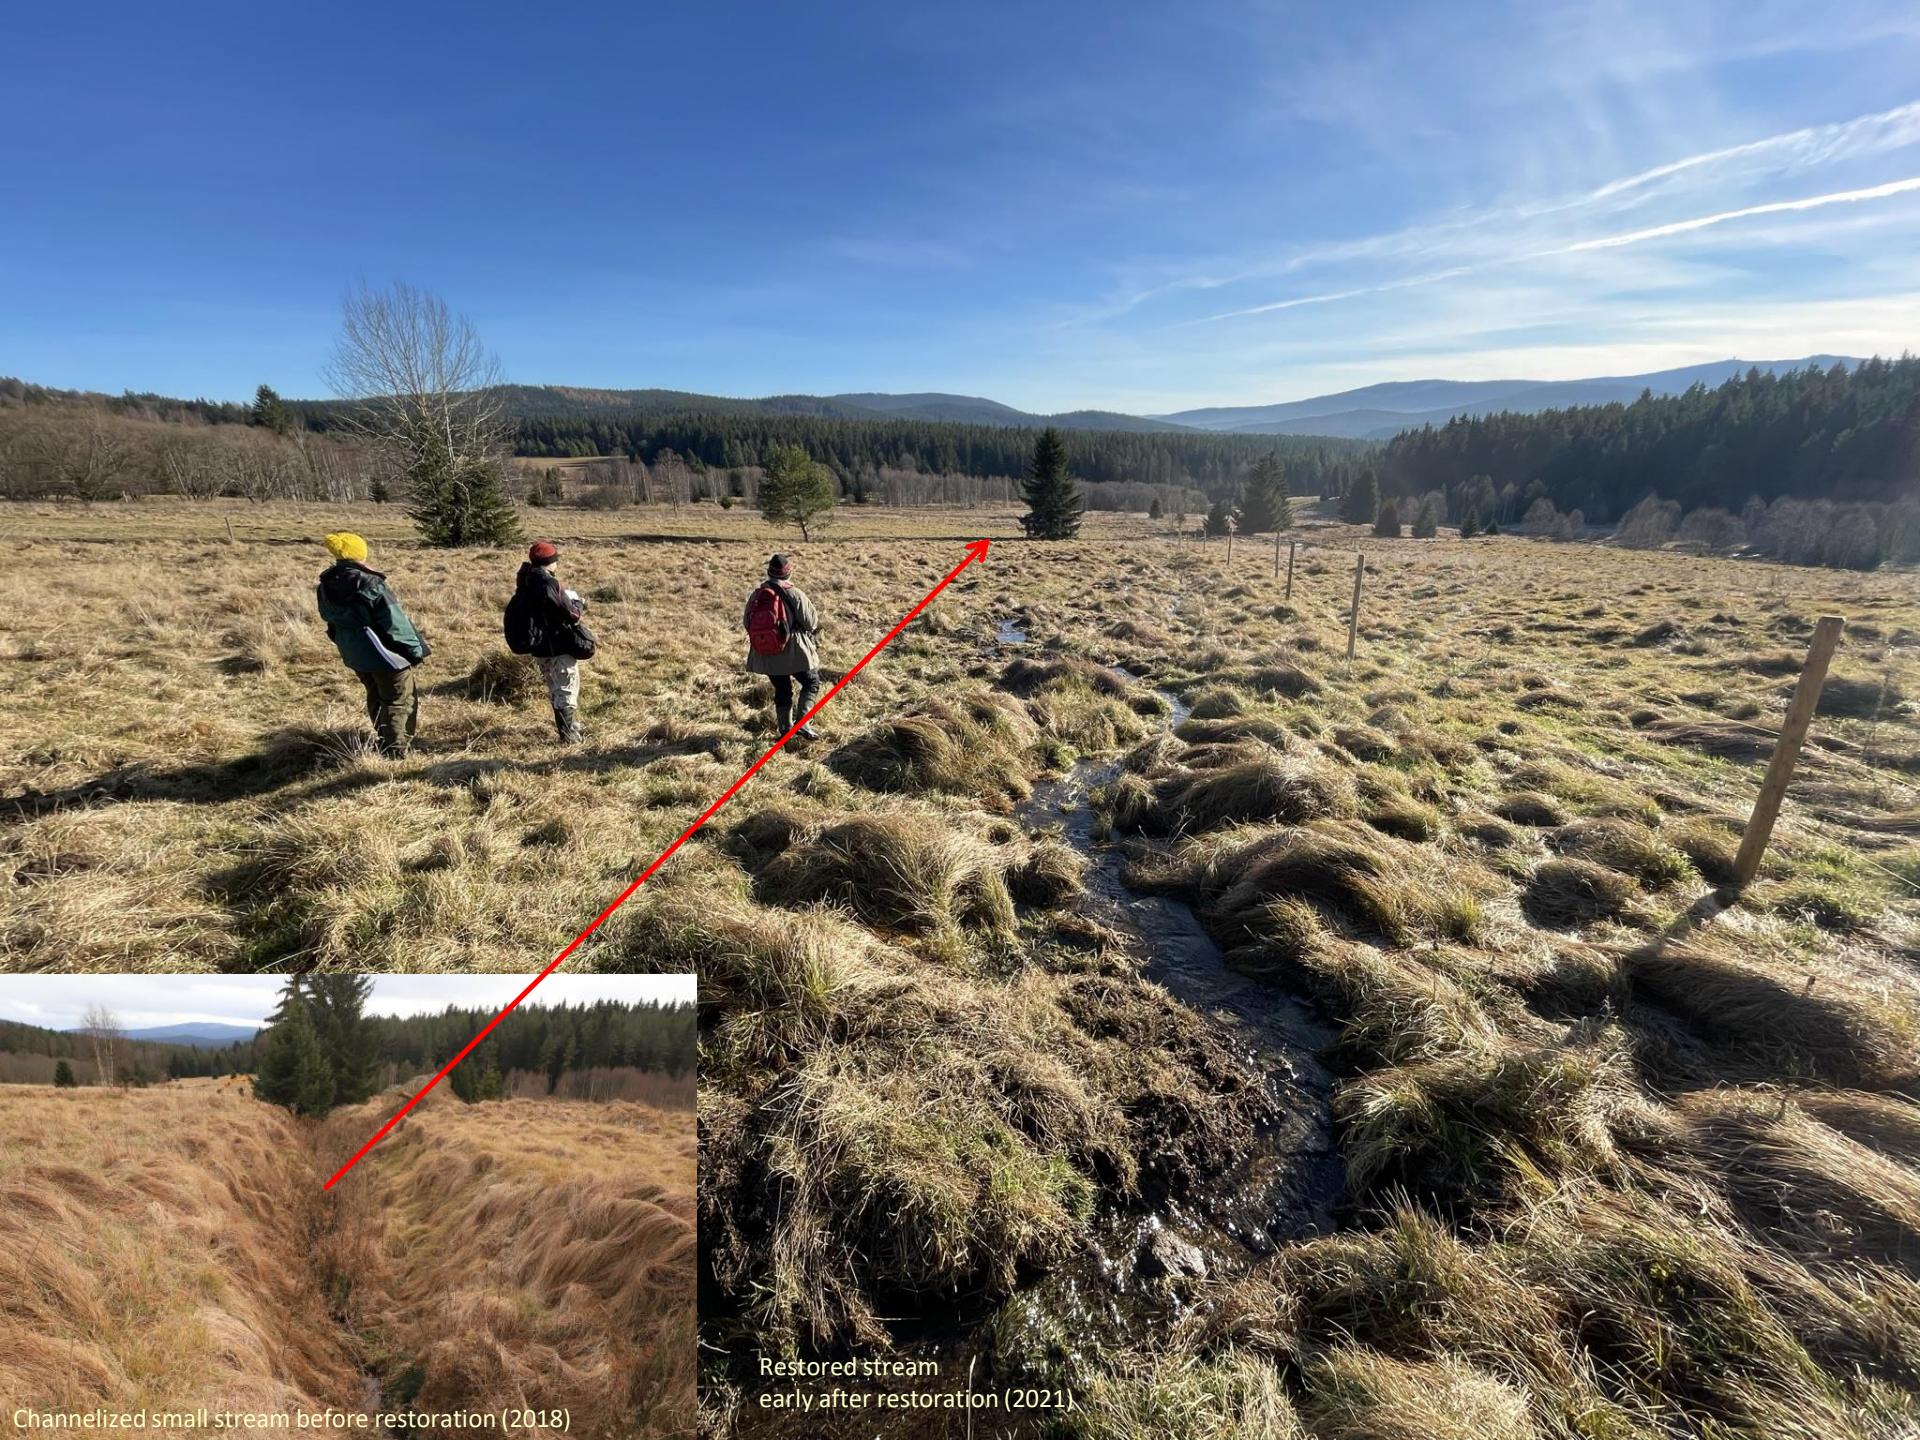
Channelized small stream before restoration (2018)

Restored stream  
early after restoration (2021)

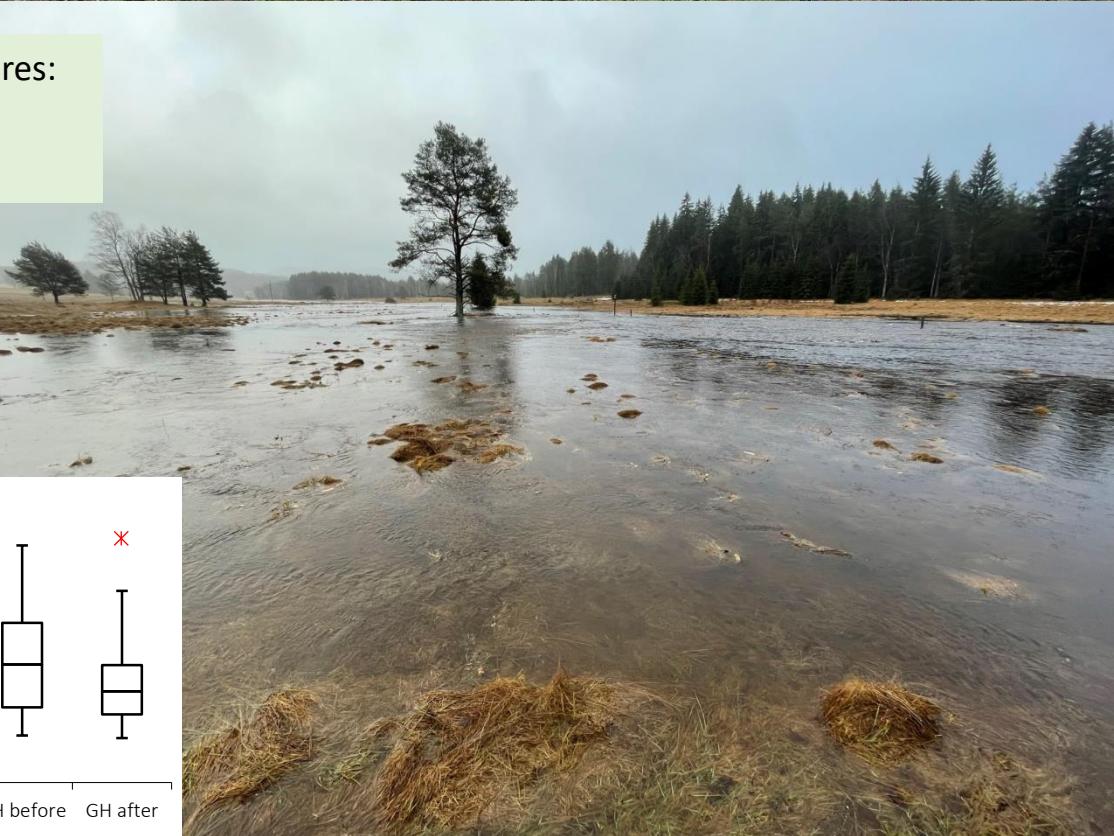
### Stream restoration as effective flood control measures:

- *earlier peak flows*
- *peak flows are lower than before restoration*
