# D.2.4.1: REPORT & PRESENTATION ON EFFECTIVENESS OF MEASUREMENT SYSTEM & CALIBRATION BASED ON THE PILOT ACTION

| Project Full Title | Bridge monitoring using real-time data and digital twins for Central Europe |

| Deliverable Title | REPORT & PRESENTATION ON EFFECTIVENESS OF MEASUREMENT SYSTEM & CALIBRATION BASED ON THE PILOT ACTION |

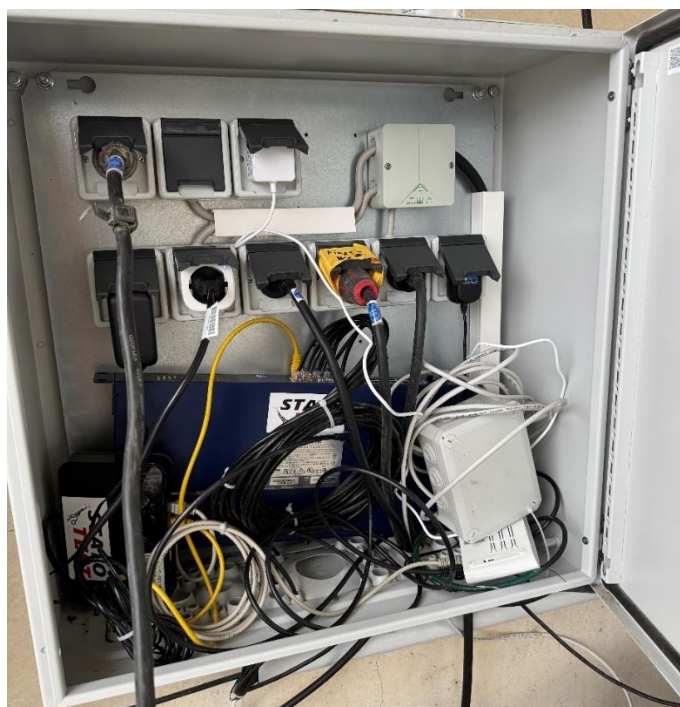
Figure 4. Case with data acquisition systems

The acquisition system was enclosed in a waterproof case, and other sensors were used on the bridge. The system was powered by a 220V power supply, converted to DC 12V using an adapter, as shown in Figure 4.
